Runway 13/31 Reconstruction Falls International Airport (INL)

Project Update

July 11, 2019 | Project Update No. 1

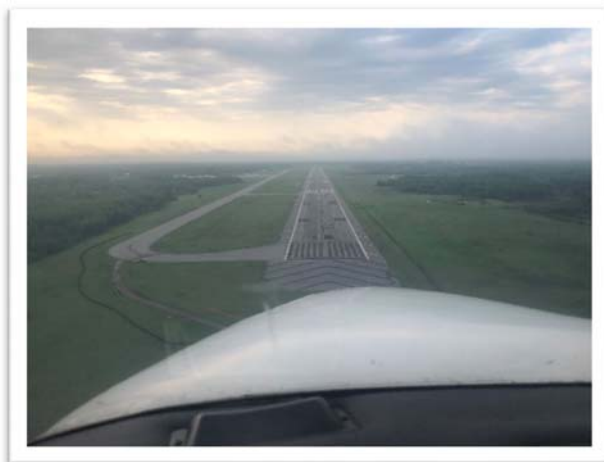
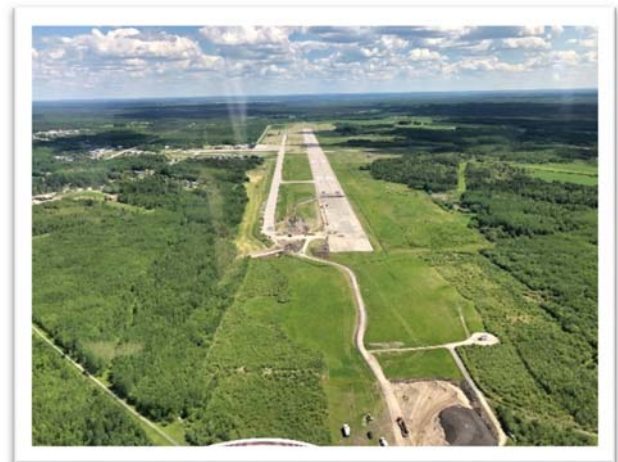
Displaced Threshold Set-up and Operation

In early June, the runway was closed during nighttime hours to complete pavement marking and electrical lighting reconfiguration to allow the runway to operate in a shortened condition. The areas to be reconstructed were painted as “closed” surfaces, and new runway markings were painted to indicate the new Runway 13 threshold. A temporary precision approach path indicator was installed to aid pilots while landing and increase safety.

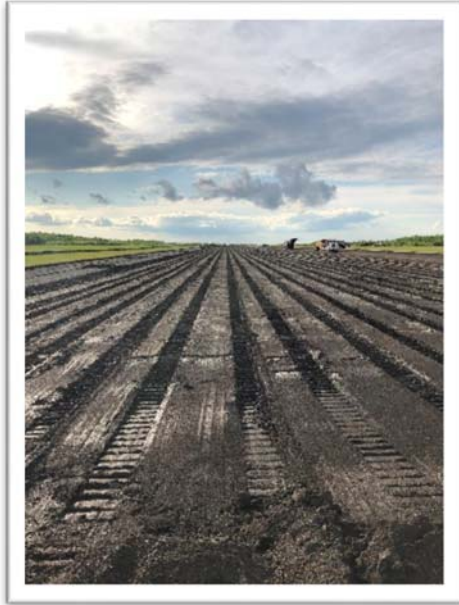
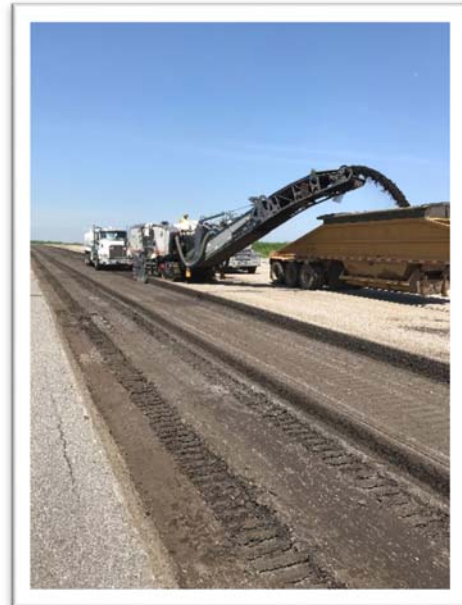
Pavement Removal

Asphalt pavement was removed using the milling process along 1000 feet of the runway. Depth varied from 4-8 inches along the taxiway, and varied from 20-24 inches along the runway. The process went very smoothly. Some of the material is being stored on-site for reuse in future materials.

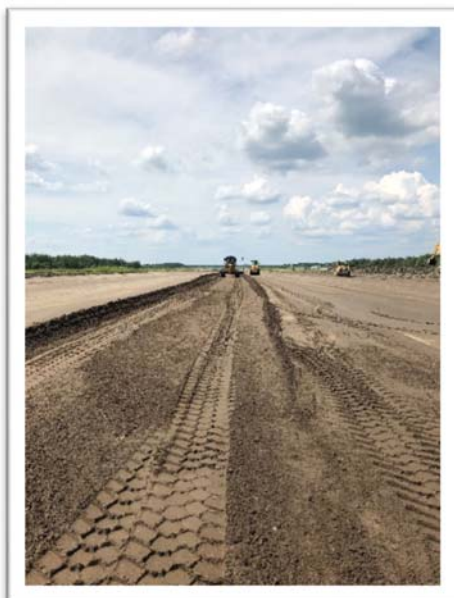
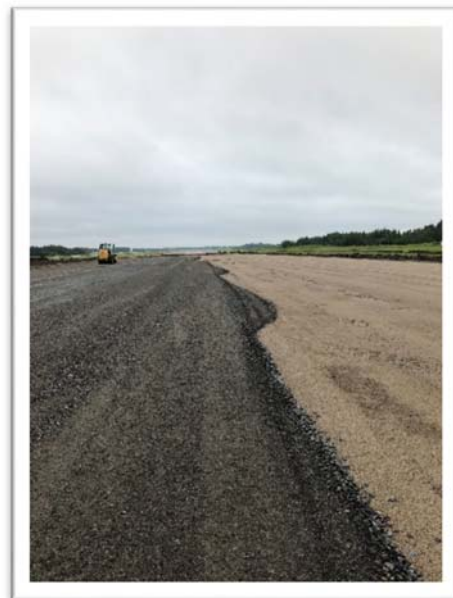
Subbase and Aggregate

The long term performance of a pavement section is dependent on the condition and suitability of the subgrade and base materials. Testing was completed on the subbase surface, verifying the material meets the required FAA gradations, compaction requirements, and other required specifications. The aggregate section is now being placed and tested in a similar fashion.

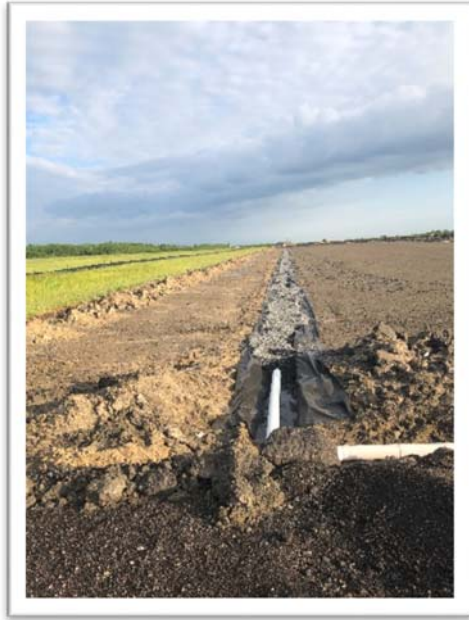
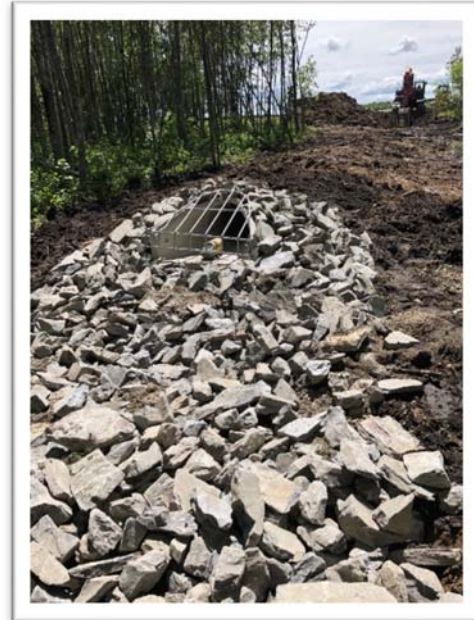
Drainage and Storm Sewer

Drainage was installed along both sides of the runway in order to provide subsurface drainage to extend the life of the pavement. Filter rock and geotextile fabric was placed around the perforated drainage pipe. The perforated drainage pipe was connected to drainage outlet non-perforated pipe. This pipe was connected into an 18" RCP storm sewer pipe system, which leads to an outlet.
